2019 AGS-GSA MARCH JOINT LUNCHEON

Ground Failures Induced by Seismic Shaking During the 2018 Anchorage, Alaska M7 Earthquake

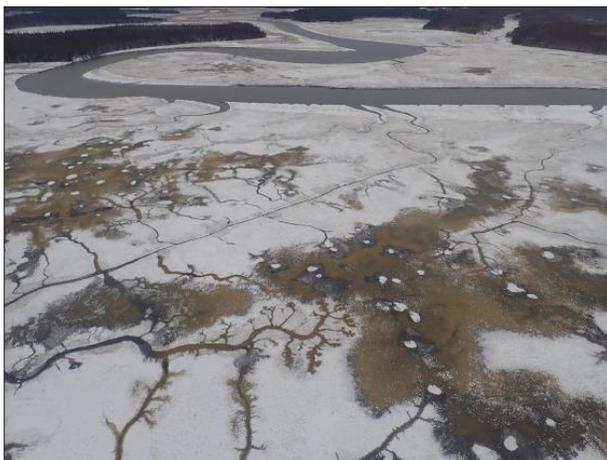
Sediment vented by earthquake-triggered liquefaction at the mouth of the Little Susitna River.

For example, landslides threatened but did not damage the Alaska Railroad at Potter Hill in 2018, adjacent to an area where landslides destroyed the railroad in 1954 and 1964. Liquefaction-related lateral spreading and sand boils occurred in tidal and deltaic environments along upper Cook Inlet and in areas of Anchorage underlain by sandy, wet soils. We also observed debris avalanches on steep slopes underlain by glacial outwash and rockfalls and snow avalanches in steeper terrain of the Chugach Mountains. Field surveys of translational landslides triggered by the 1964 earthquake identified minor cracking (≤ 0.01 m wide, ~32 m long) along the margins of landslide blocks and grabens, but no evidence for significant net displacement. We speculate that the duration (20–40 sec) of shaking in the 2018 Anchorage earthquake stopped short of reactivating large translational landslides that failed during much longer (4 to 5 min) shaking in 1964. Our observations will be used to empirically check the USGS ground-failure products that depict areas prone to coseismic liquefaction and landsliding.

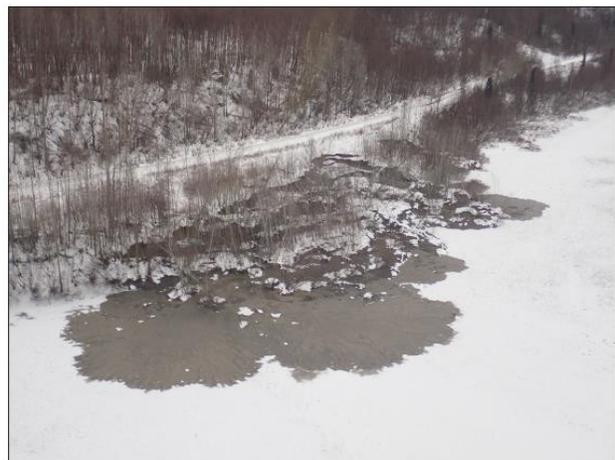
Complex earthflow slumping along Alaska Railroad overlooking tidal flats along Knik Arm near Mirror Lake.
